THE INSTITUTE OF PAPER SCIENCE AND TECHNOLOGY

Corrosion in Electrostatic Precipitators

Project 2926-9

R E P O R T T W O

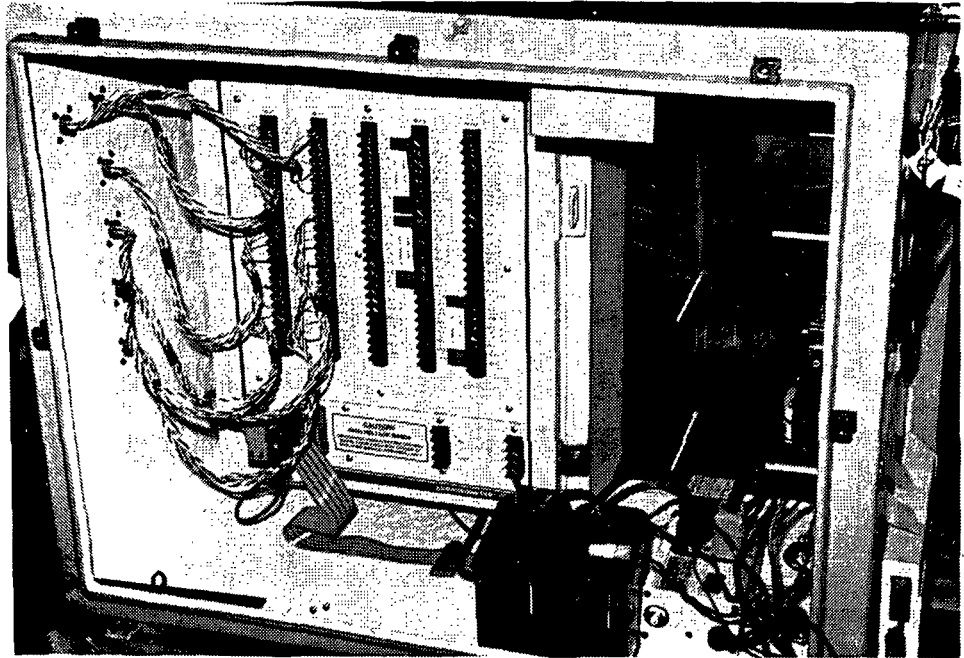
At the Springfield mill, a multichannel electrical resistance (ER) system with remote data acquisition capabilities was installed (Fig. 1). After a long period of problems relating to electronics and probe designs, the system was finally employed successfully and corrosion rates were measured on-line in the No. 3 precipitator.

Figure 1. The ER system, microcomputer, and modem mounted in a weatherproof enclosure and installed in a control room on the roof of the No. 3 electrostatic precipitator at the Weyerhaeuser mill.

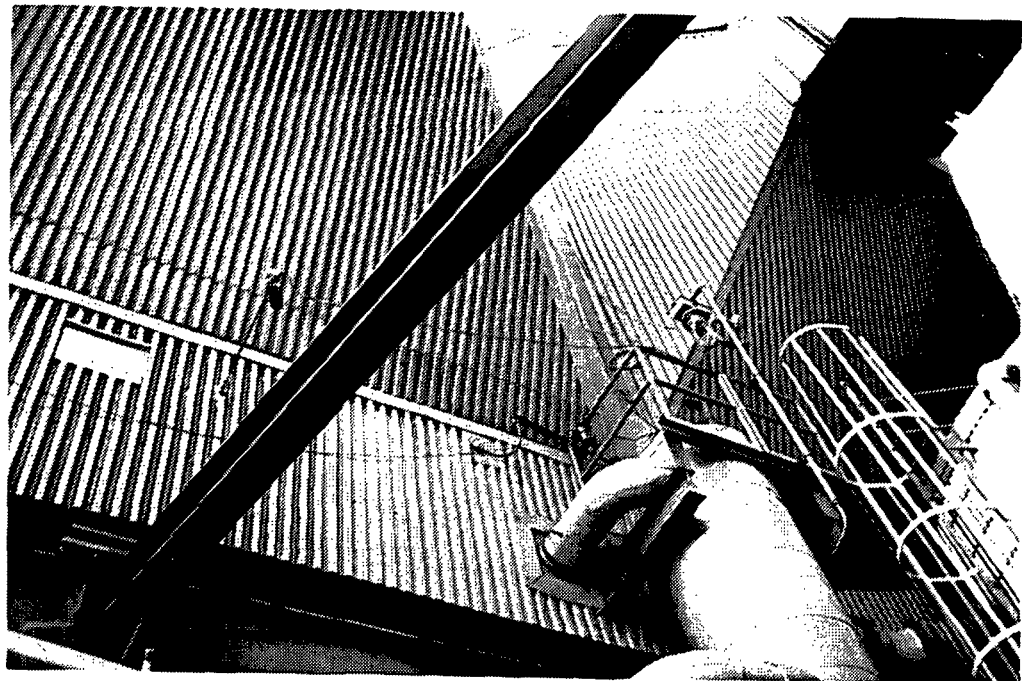
Six ER probes were installed at access ports along the north wall of the precipitator. This is at the outlet end of the precipitator where extensive corrosion damage historically had occurred (Fig. 2). Both flush mount and retractable probes were used, with one retractable and two flush mount probes installed in each of the east and west chambers of the precipitator (Figs. 3 and 4). The locations of the ER probes are shown in a schematic diagram of the precipitator in Fig. 5.

Figure 2. A view looking upward at the north wall of the No. 3 precipitator. Probes can be seen installed along the lower area of the wall, below the outlet ductwork.

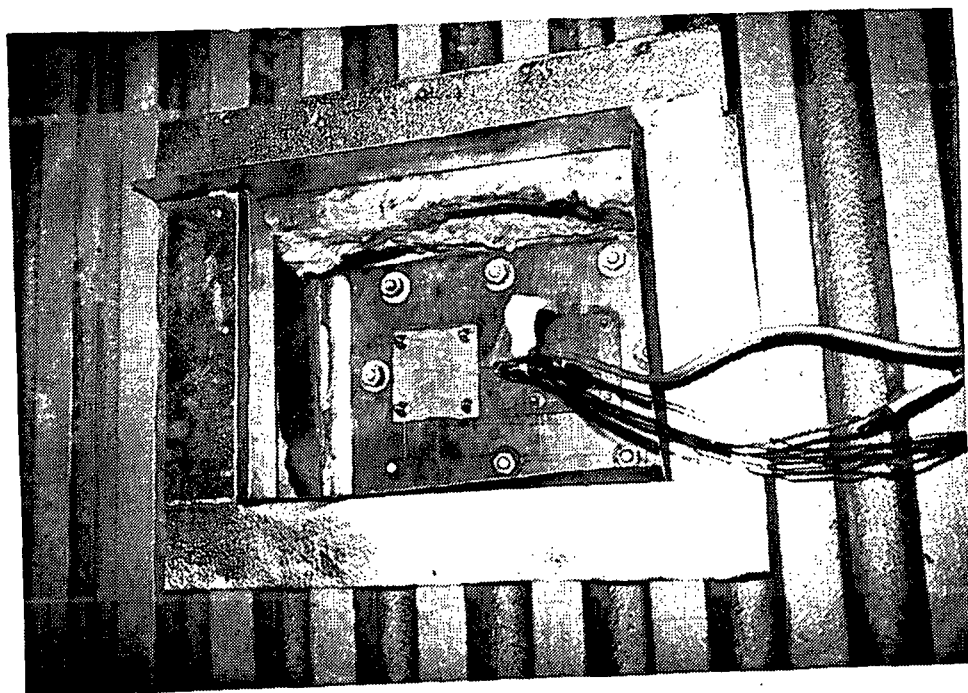
Figure 3. Flush mount ER probes were installed on access plates in both the east and west chambers of the precipitator.

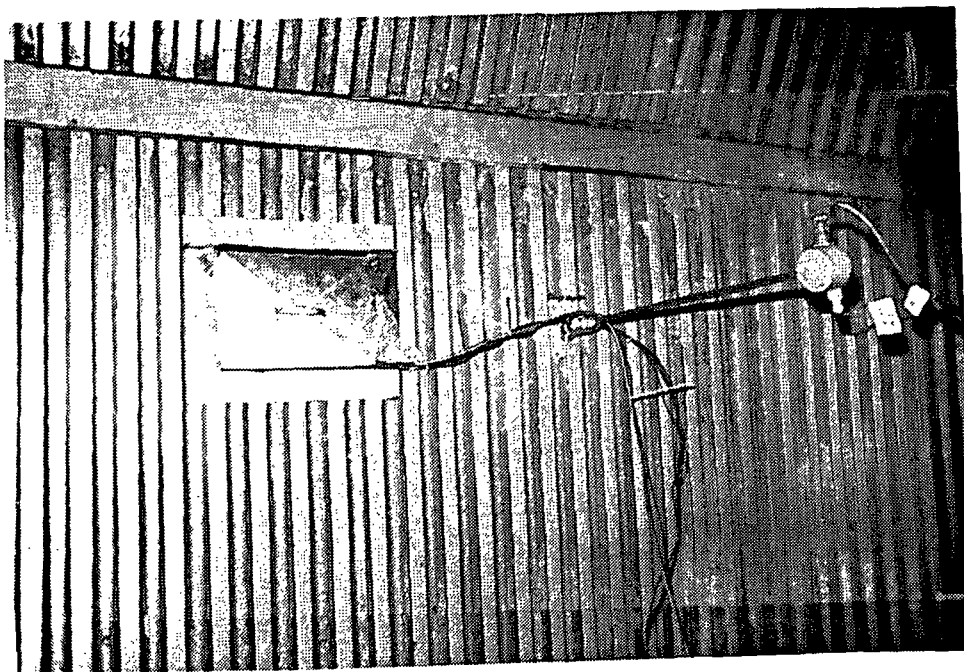
Figure 4. Retractable ER probes were installed adjacent to the flush mount probes along the north wall in both chambers of the precipitator.

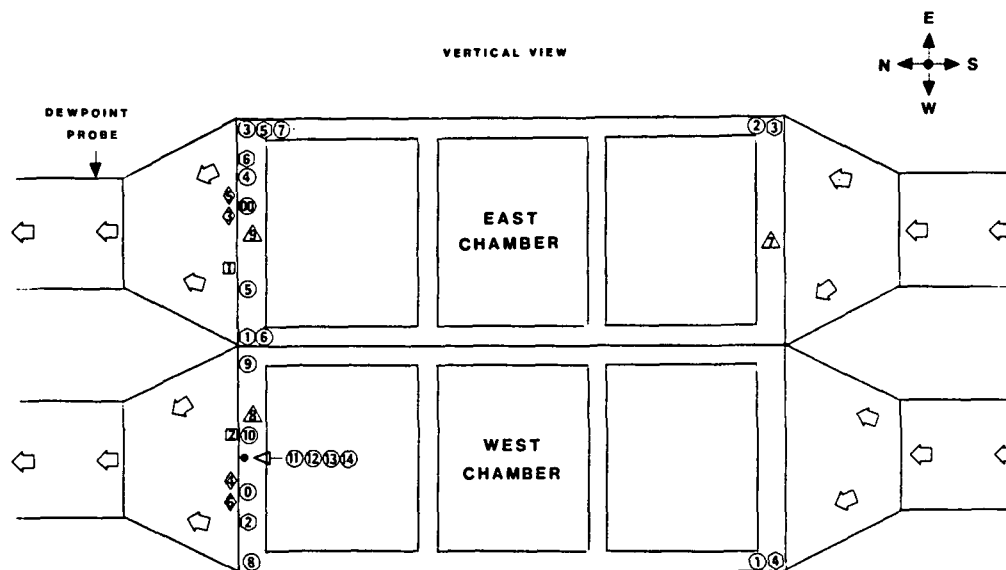
At the same time that the six panels discussed above were installed in the No. 3 precipitator, three panels containing coated specimens were also installed. The locations of these panels are shown in Fig. 5.

Figure 5. Springfield No. 3 precipitator showing test locations.
(Key in Figure 6)

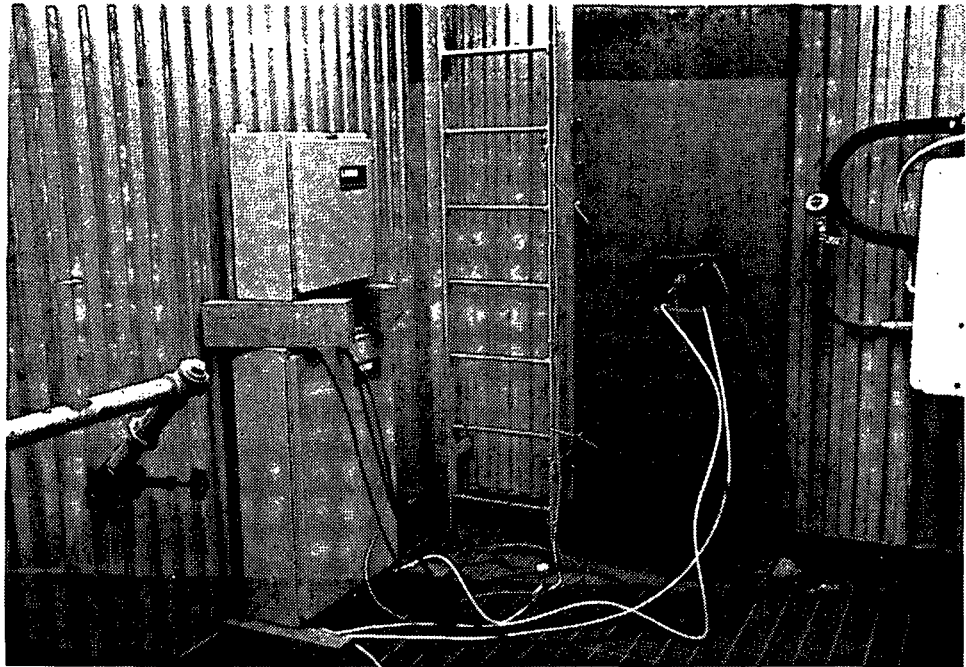
The dew point monitoring technique was employed as a second on-line monitoring method. The dew point method employs the use of a cooled conductivity probe placed in the flue gas stream. The conductivity probe provides for a direct measurement of the flue gas dew point (Figs. 7 and 8). The instrument output -- a temperature value -- was recorded on a strip chart recorder. The location of the conductivity probe is shown in Fig. 5.

Figure 7. The dewpoint probe and related electronics were installed in the outlet ductwork at the east side of the No. 3 precipitator.

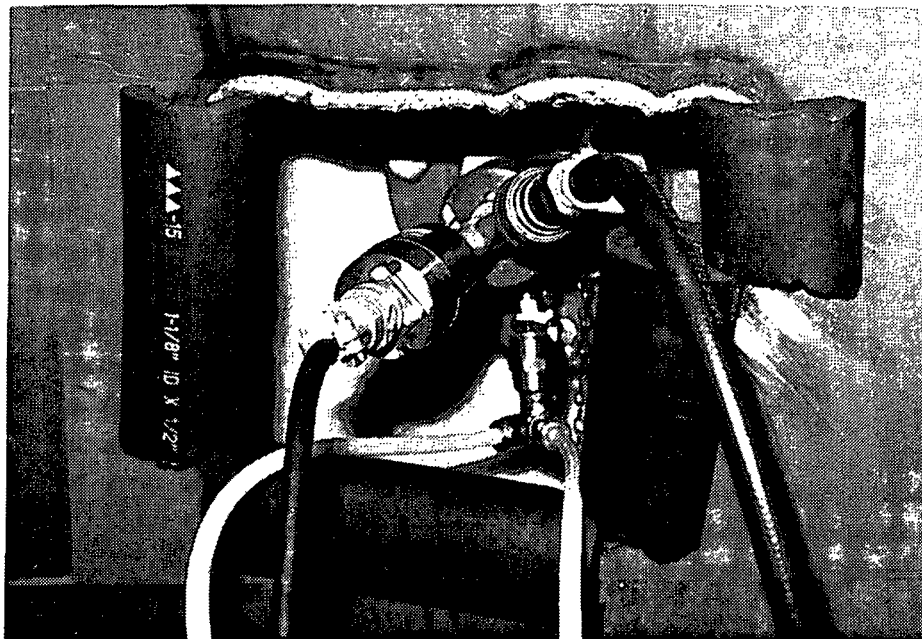
Figure 8. A close-up view of the conductivity probe shown in Figure 7. The hoses are required for periodic air cooling and water cleaning of the probe element surface.

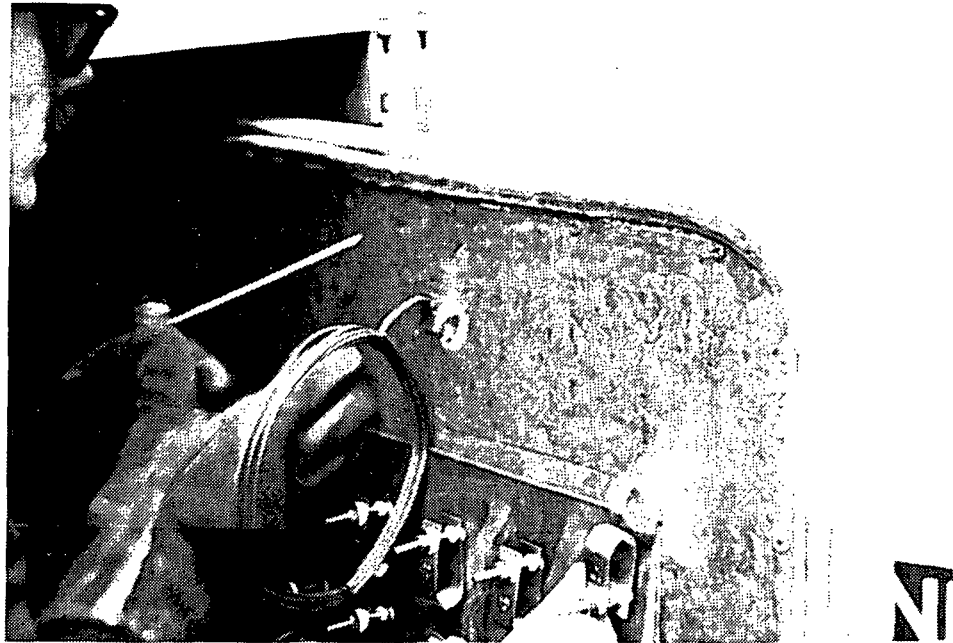
Figure 9. A weld pad thermocouple is shown being welded to the internal side of an access door of the precipitator for a metal surface temperature measurement at that location.

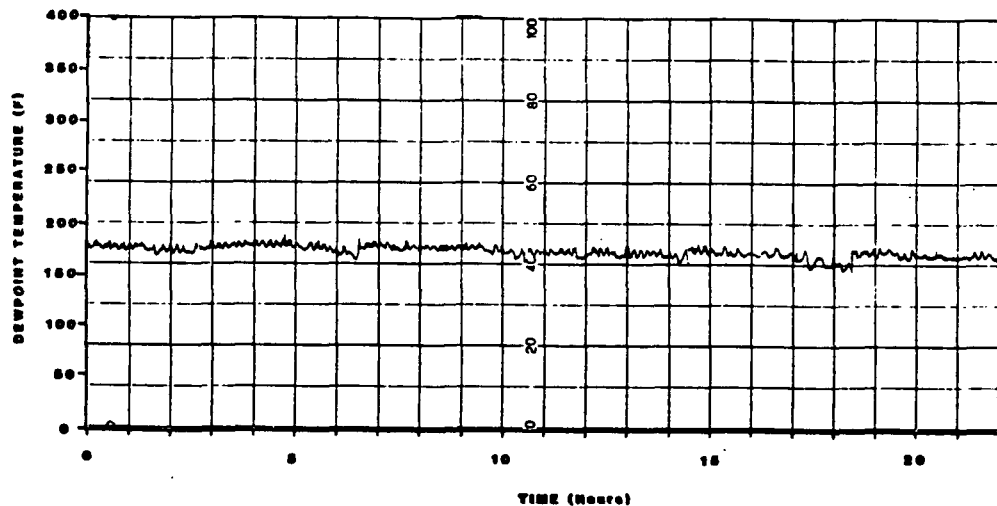
Results: Readings with the dew point probe indicated dew points that ranged from 160 - 175 °F during typical boiler operating conditions (Fig. 10). Data from the sixteen internal surface thermocouples revealed temperature values that ranged from 140 - 300 °F (thermocouple location dependent) during routine boiler operation and corresponding precipitator gas inlet temperatures of 310 - 340 °F. Temperatures were found to be greater on internal surfaces at the inlet end of the precipitator and in the upper portions of the precipitator. The inside surfaces of sidewalls (approx. 240 °F) were cooler than the chamber dividing wall (approx. 280 °F) at intermediate levels in the precipitator. The inside surfaces of the double door access ports were at a higher temperature than the single doors, regardless of the door location in the precipitator. The lowest temperatures, and the only temperatures that measured at or below the dew point, were found at the outlet end at low levels of the precipitator near the liquor bath. Note, however, that similar locations

Figure 10. The flue gas dewpoint temperature typically ranged from 160-170°F during routine operation of the No. 3 recovery boiler.

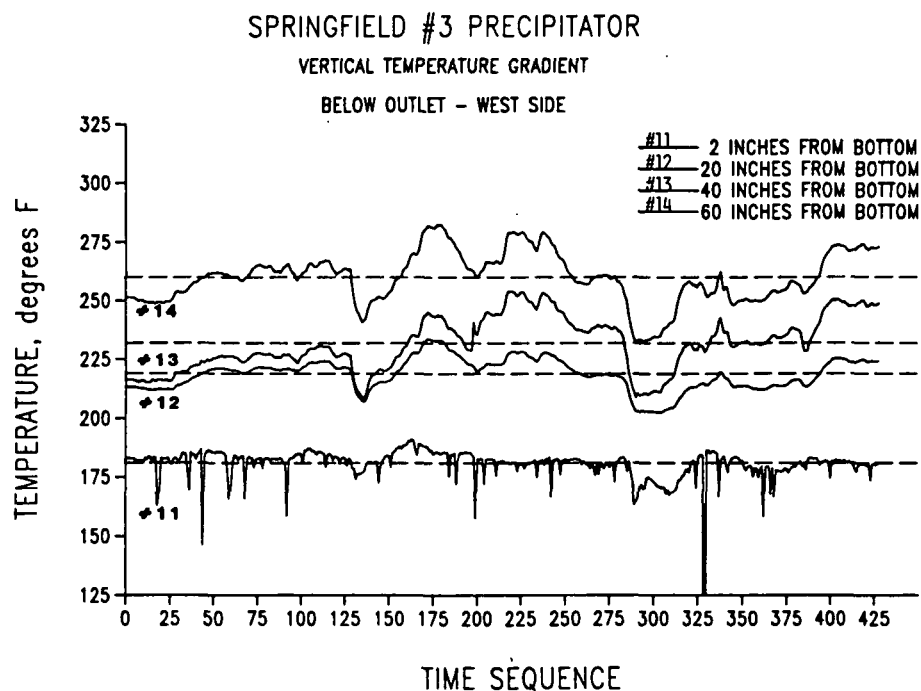
were not heavily instrumented at the inlet end. A dramatic reduction in the metal surface temperature was observed toward the level of the liquor bath, at elevations beginning near the bottom of the collector plates (approximately 6 feet from the floor of the precipitator). A vertical temperature profile for the lower outlet wall of the west chamber of the No. 3 precipitator is shown in Fig. 11. The lowest thermocouple (#11) was most likely immersed in the liquor bath and therefore indicates liquor temperature. The other thermocouples were located at higher elevations and all resided in the flue gas stream. It is apparent that proximity to the liquor bath results in a cooler wall surface temperature, a condition which promotes condensation and therefore corrosion.

Figure 11. A vertical temperature profile for internal metal surfaces along the outlet wall of the No. 3 precipitator. Note: Dotted lines indicate average values.

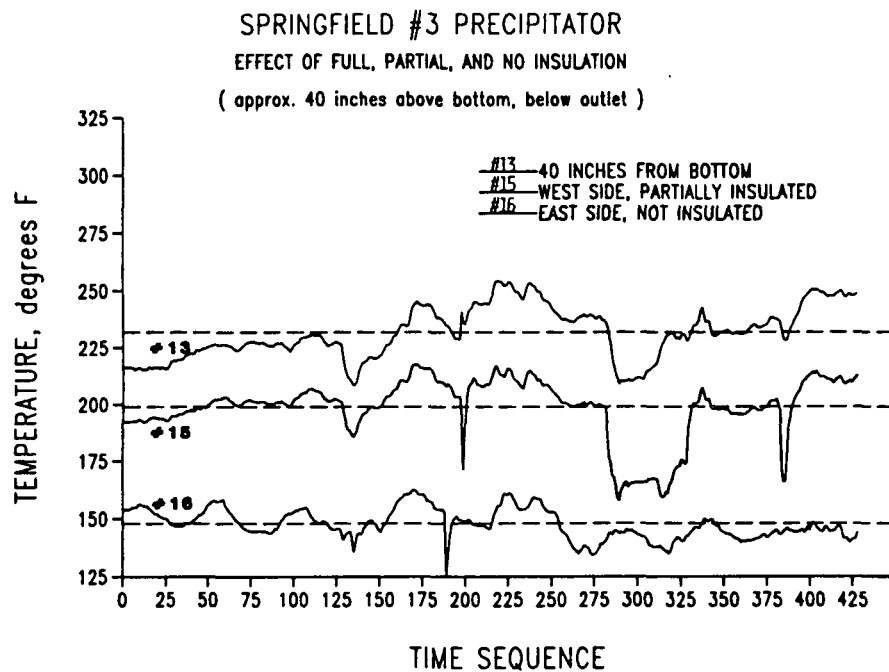
The effect of thermal insulation on the retention of heat along wall surfaces was determined at similar elevations along the outlet end wall. The effects of full insulation (with no heat jacketing), partial insulation, and no insulation are shown in Fig. 12. For a completely uninsulated plate the average internal surface temperature was less than 150 °F, for a moderately (approximately 2" fiber fill) insulated plate the temperature was close to 200 °F, and a heavily (approximately 4" fiber fill) insulated plate resulted in an average temperature of around 230 °F.

Figure 12. The effects of insulation on temperature retention of internal wall surfaces. Note: Dotted lines indicate average values.

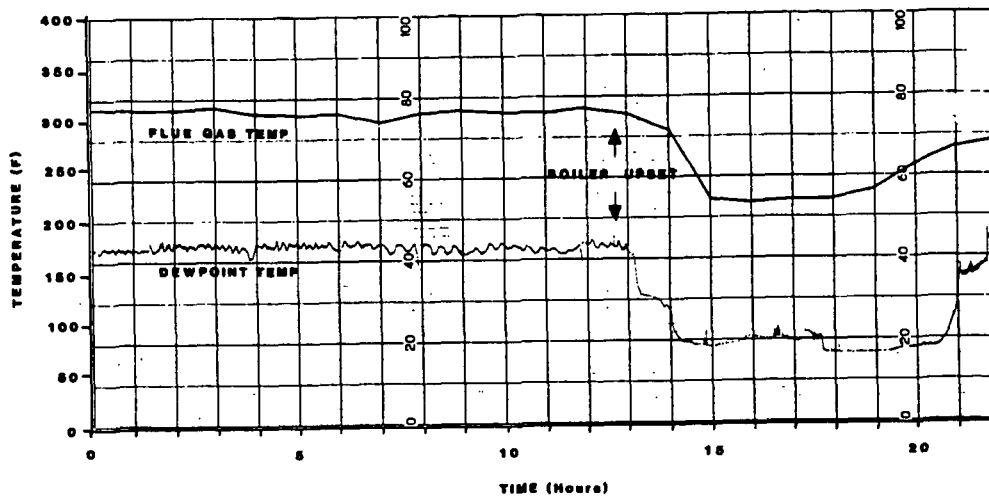
Results: The precipitator inlet temperature drop related to the trip-out of the boiler resulted in a corresponding drop of dew point. Apparently, the dew point tends to parallel the flue gas temperature (Fig. 13). A plausible explanation for this result, relative to the water dew point theory, is that the cool flue gas contained less water vapor, which resulted in the lower dew point. As the furnace bed cooled during the upset, a lesser quantity of water driven off during liquor combustion would be dismissed in the resulting flue gas. Also, the cooler flue gas would not pick up as much water from the black liquor while passing through the cascade evaporator. If other factors are equal, a decrease in liquor solids content at the cascade evaporator (indicative of reduced water removal) almost always results from a low load firing recovery boiler.

not result in an aggressive corrosive environment in the precipitator. From Fig. 13, it can be seen that the difference in temperature between the flue gas and dew point remains fairly constant during the upset period. This temperature margin can be thought of as a measure of corrosion safety, provided that some measurements or knowledgeable assumptions are made regarding the relationship between flue gas temperature and internal surface temperatures.

Figure 13. A recording of the precipitator inlet flue gas temperature and the dewpoint temperature. Both measurements were made in the east side ductwork system. Note the tendency for the dewpoint temperature to swing with the flue gas temperature.

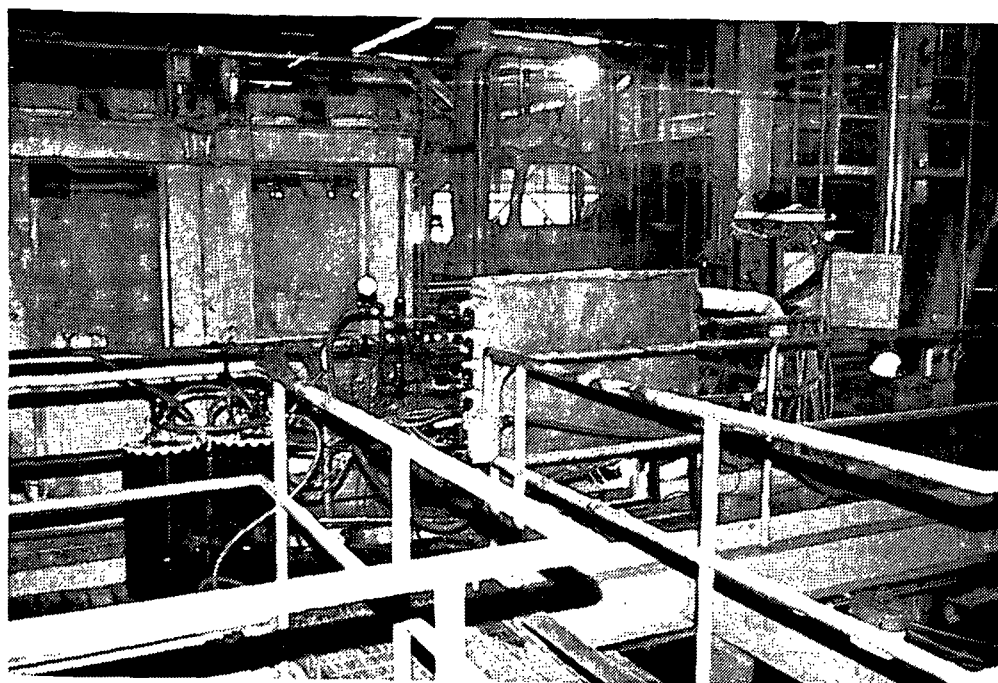
Figure 24. Corrosion chamber as installed at the Charleston mill.

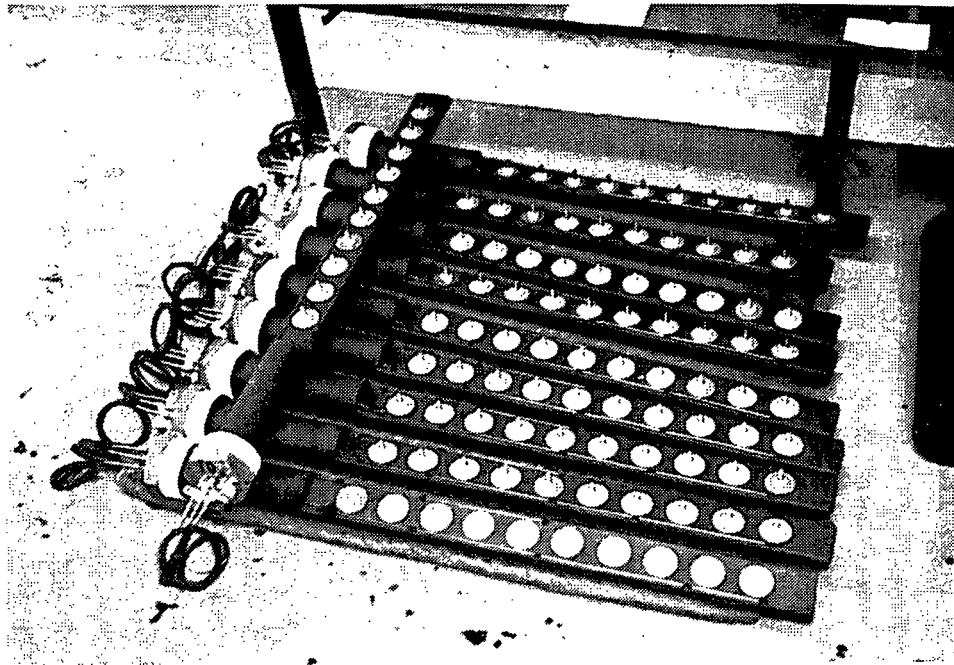
Figure 25. Ten cold finger assemblies before installation in the corrosion chamber at the Charleston mill.

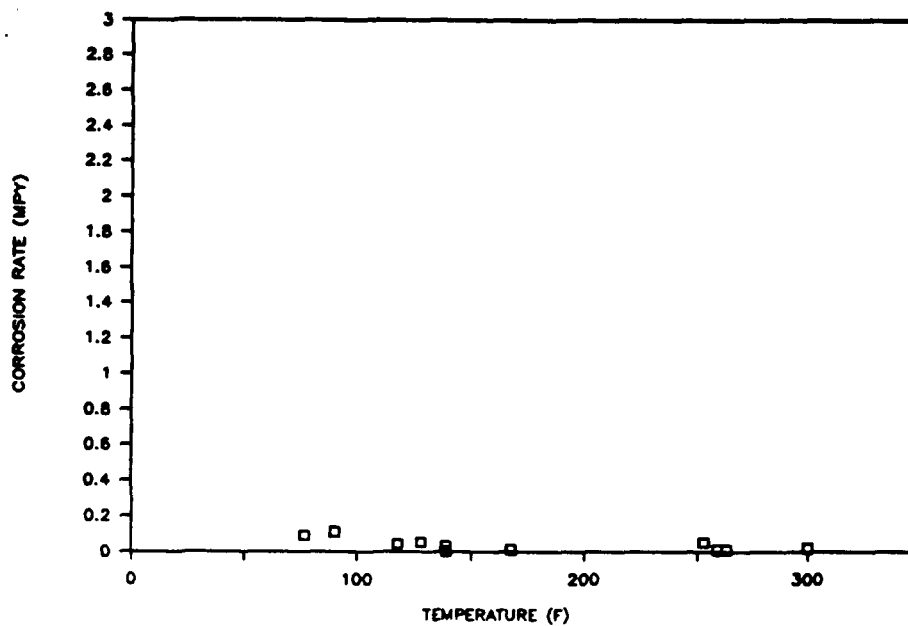
HASTELLOY C-22

Figure 26-q. Corrosion data from the Charleston mill.

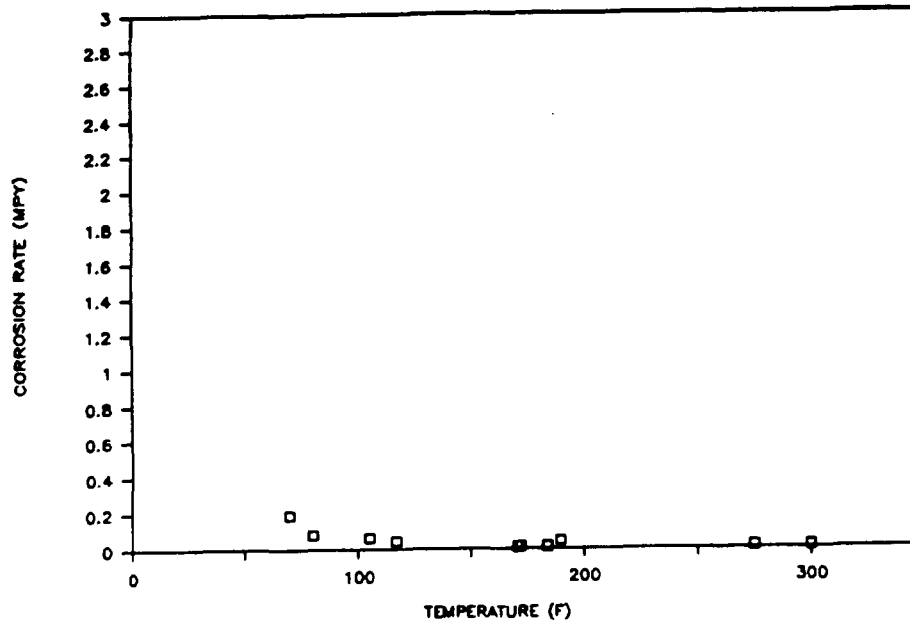
INCOLOY 825

Figure 26-r. Corrosion data from the Charleston mill.

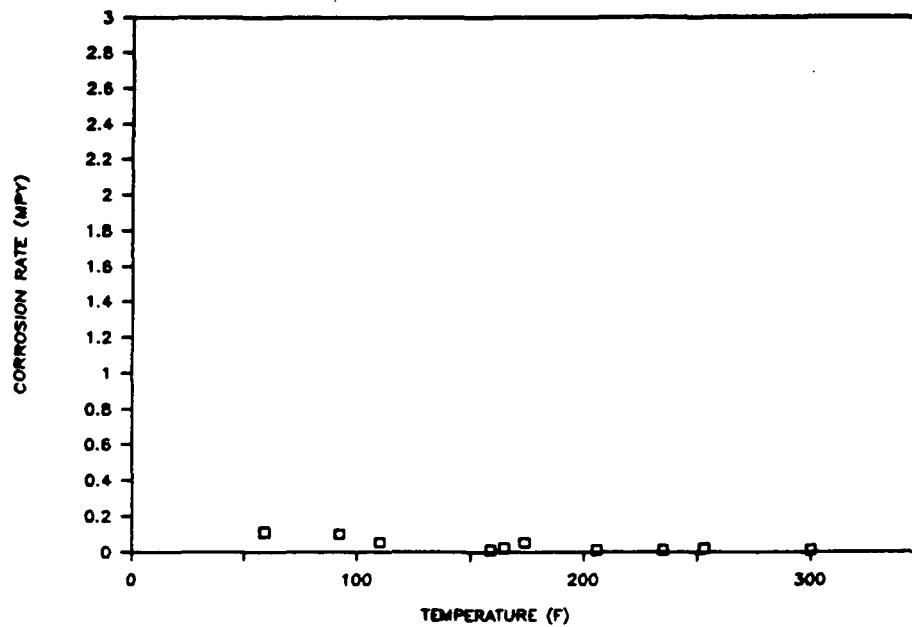
INCONEL 625

Figure 26-s. Corrosion data from the Charleston mill.

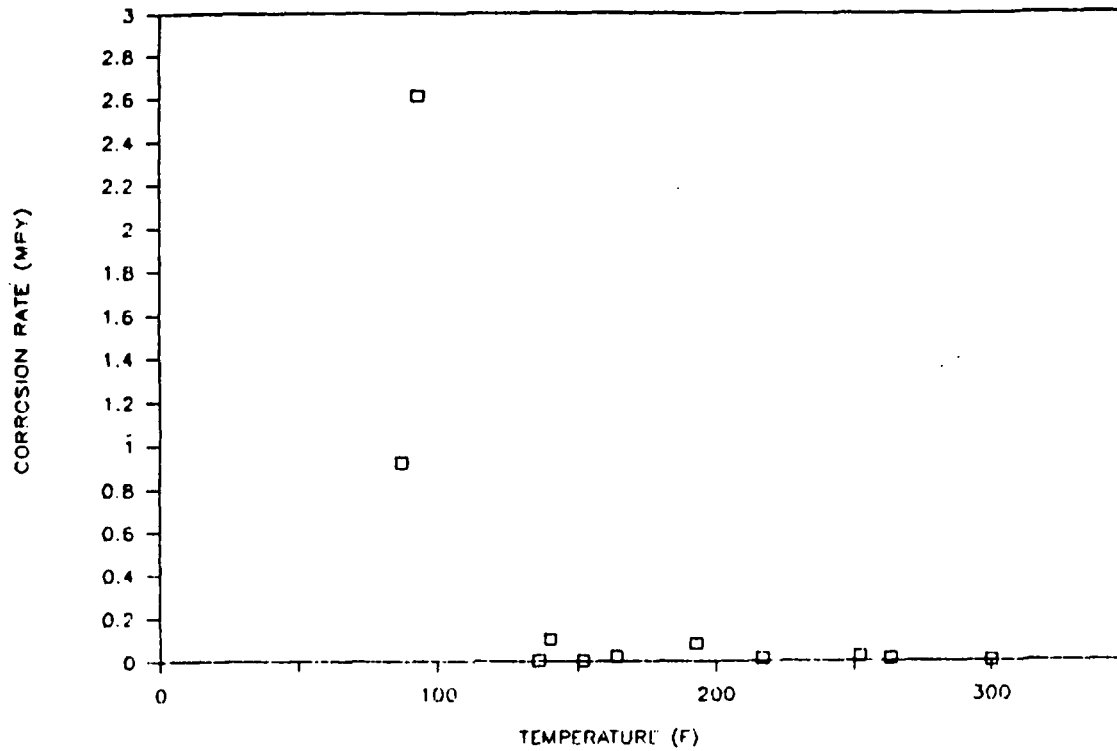
TITANIUM GR.1

Figure 26-t. Corrosion data from the Charleston mill.

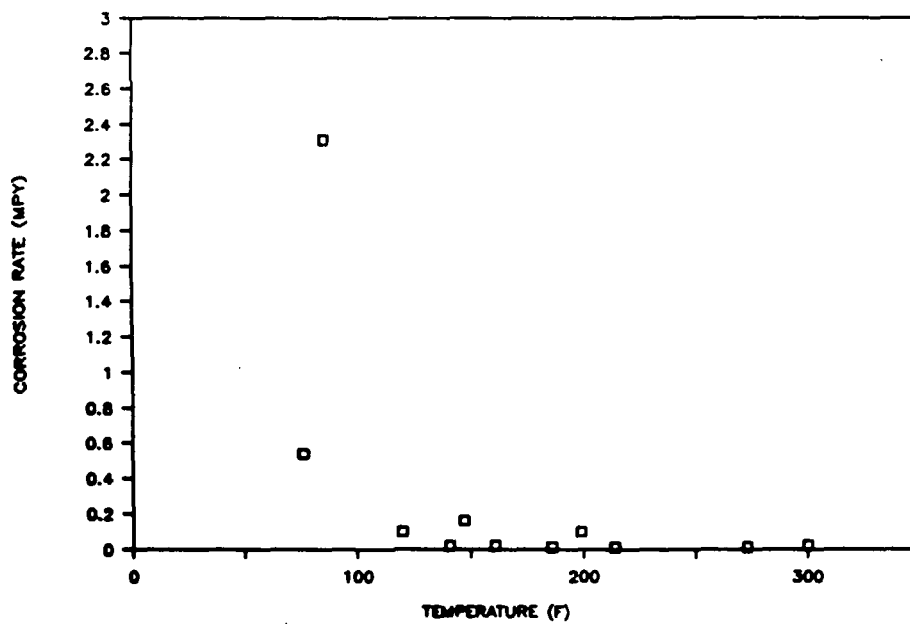
TITANIUM GR.7

Figure 26-u. Corrosion data from the Charleston mill.

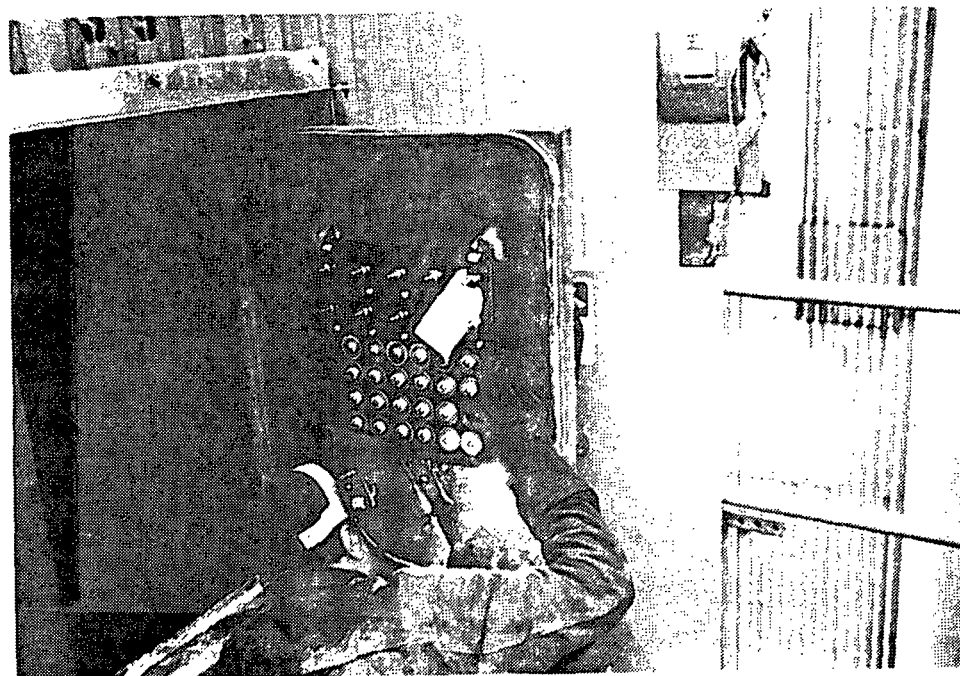
Figure 27. Test panels were mounted in the precipitator by welding to various surface locations. Shown here is a panel being installed on the internal side of an access door.

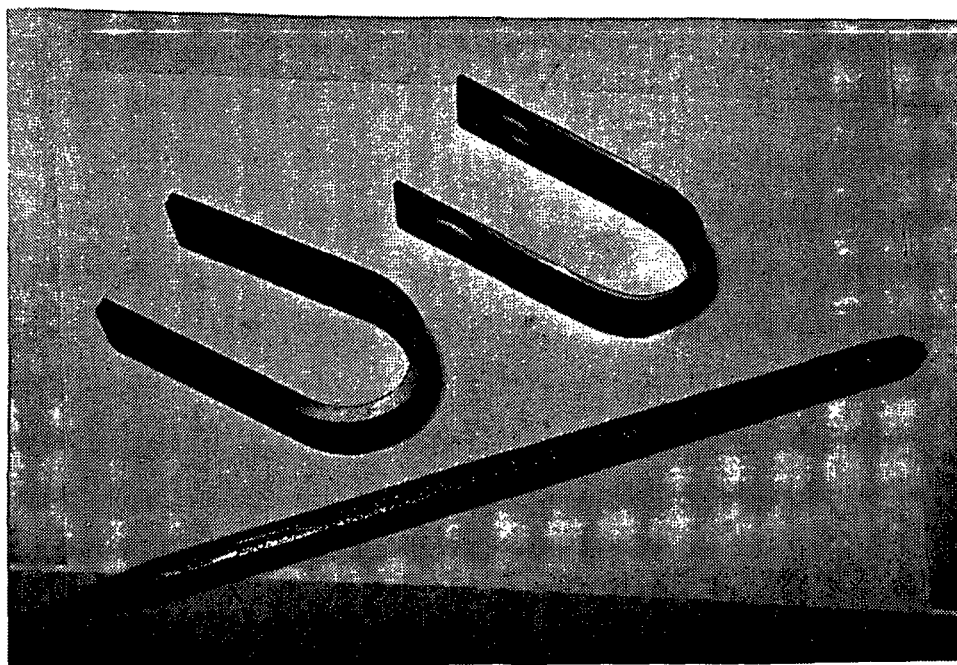
Figure 28. U-bend specimens were exposed in the precipitator, cleaned, and carefully examined at the stressed area for evidence of cracking.

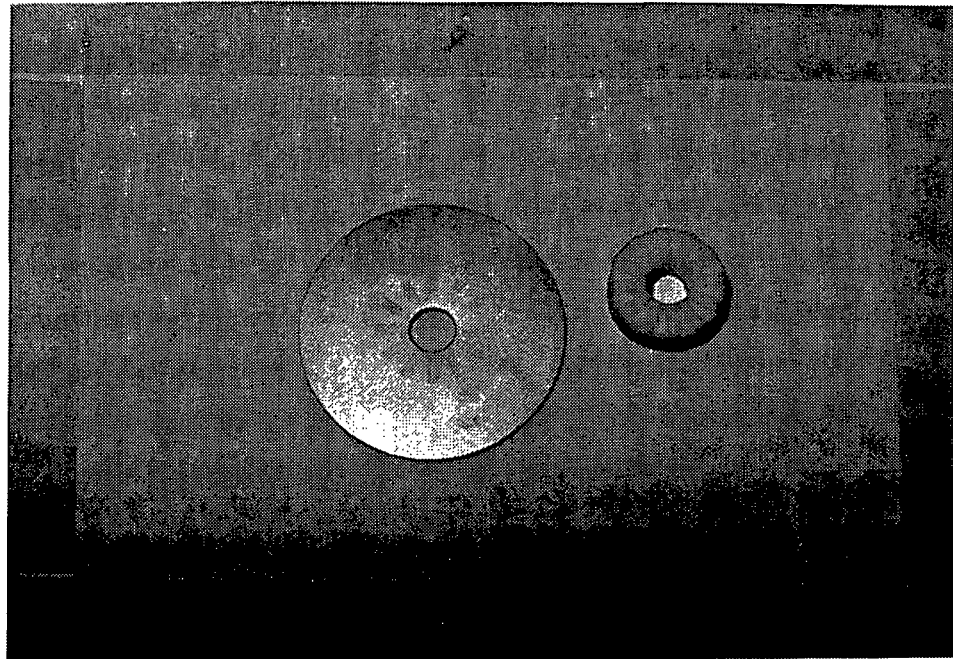
Crevice corrosion tests were conducted on 304L, 310, and 316L stainless steels. Specimens of each type were fitted with Anderson type crevice washers and installed on each of the six test panels. None of the materials exhibited localized attack in the form of crevice corrosion at any of the test locations (Fig. 29).

Figure 29. A 310 stainless steel specimen is shown with a standard crevice washer. Note the imprint that the washer left on the specimen surface, but no crevice corrosion was observed following an exposure in the No. 3 precipitator.

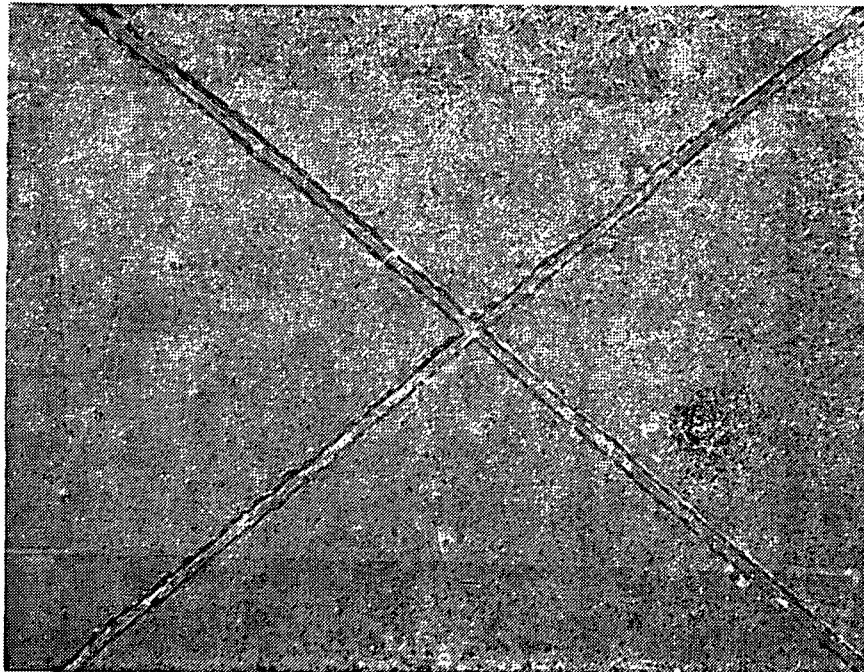
exposed on panel No. 7. Cracking was not dependent upon proximity to surface defects for the S&G 350 coating as is shown in Fig. 31. It can be seen from Fig. 32 that cracking of the S&G 350 coating resulted in the exposure of the underlying carbon steel. Continued exposure under such circumstances would likely result in disbondment and delamination of the coating over a period of time. Much better performance was exhibited by the S&G 500 coating in similar exposures (Fig. 33).

Figure 33. A specimen coated with S&G 500 did not crack when exposed to the same conditions as S&G 350. (6X)

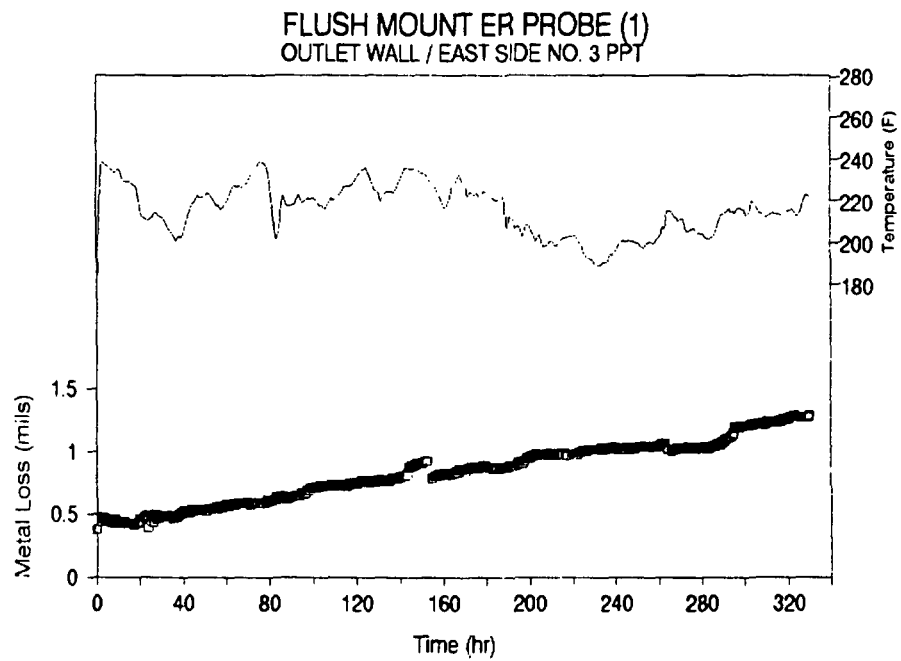
The results are shown in Figs. 45 - 48. Unfortunately, the temperature at the location of the probes was not below the water dew point for any extended period of time. The corrosion rates measured for all of the flush mount ER probes were fairly constant throughout the test, and as shown in Fig. 49, this rate was maintained for over 1000 hours, at which time the monitoring was terminated due to the relocation of the Institute. The test may not have helped to reveal any new information regarding the effect of varying recovery boiler operations on precipitator corrosion, but it did show that with thicker ER probes the corrosion rate can be monitored for long periods of time. The retractable ER probes did not work at any time during the monitoring period despite several attempts by mill personnel to correct the problem.

Figure 45. ER probe results from the Springfield mill.

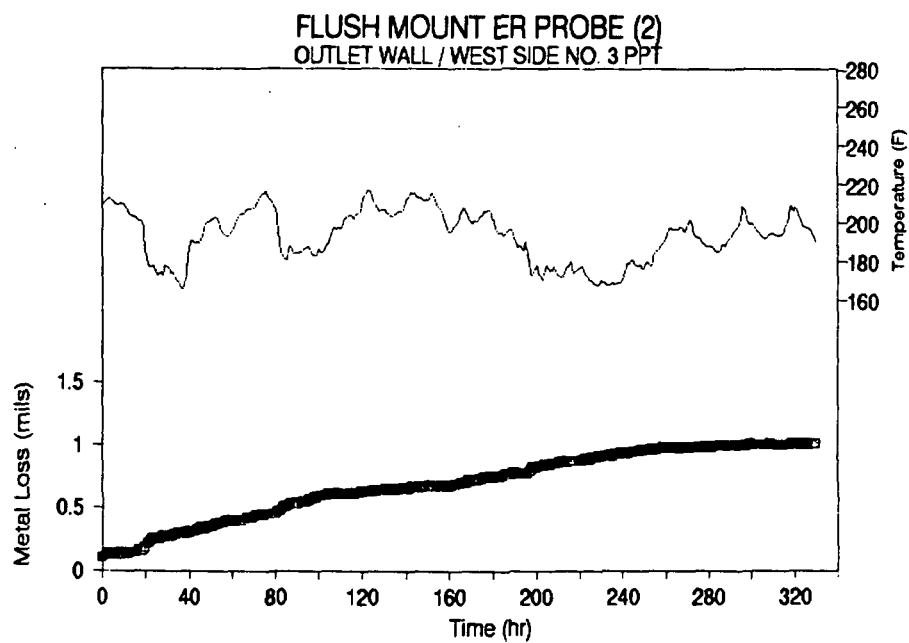
Figure 46. ER probe results from the Springfield mill.

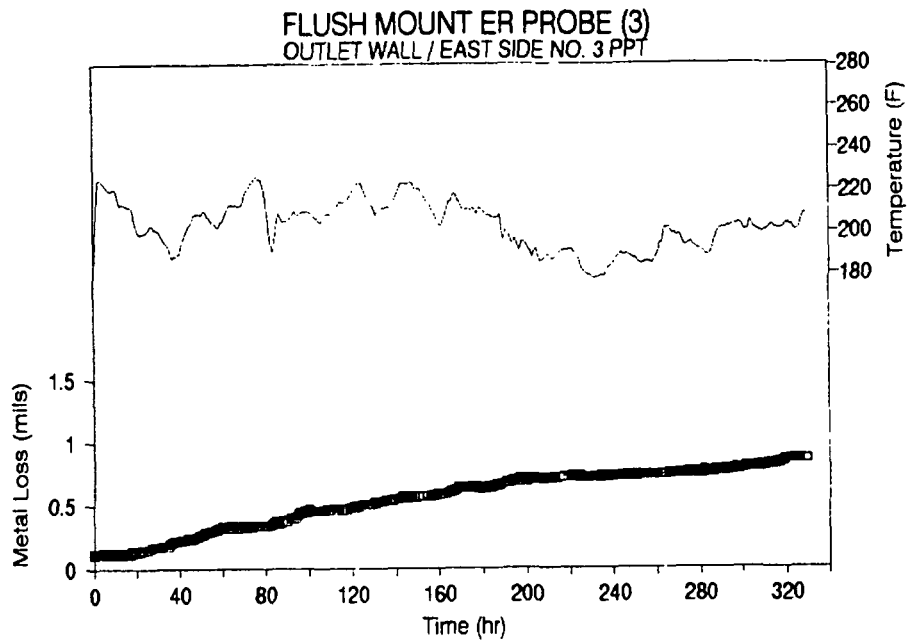
Figure 47. ER probe results from the Springfield mill.

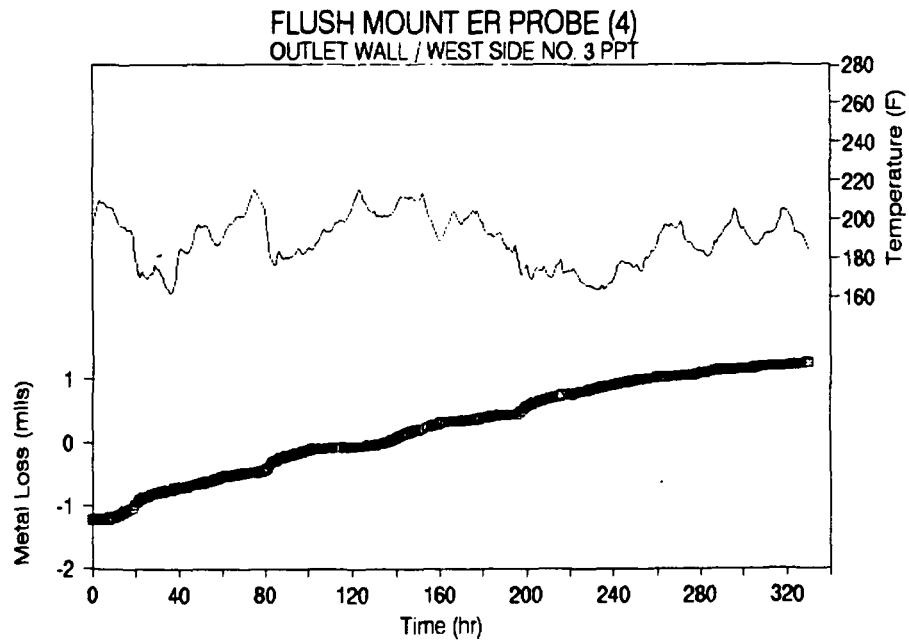
Figure 48. ER probe results from the Springfield mill.

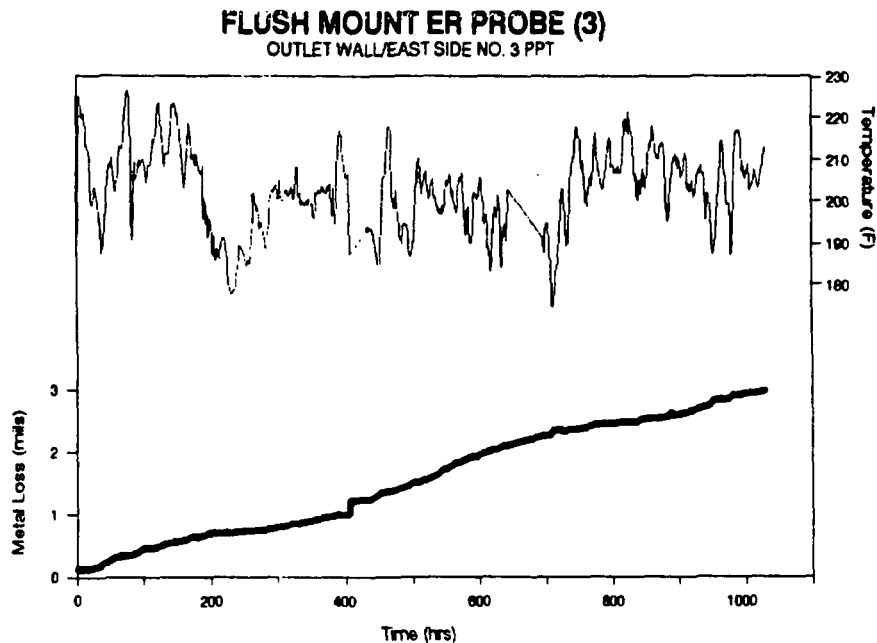
Figure 49. ER probe results from the Springfield mill.

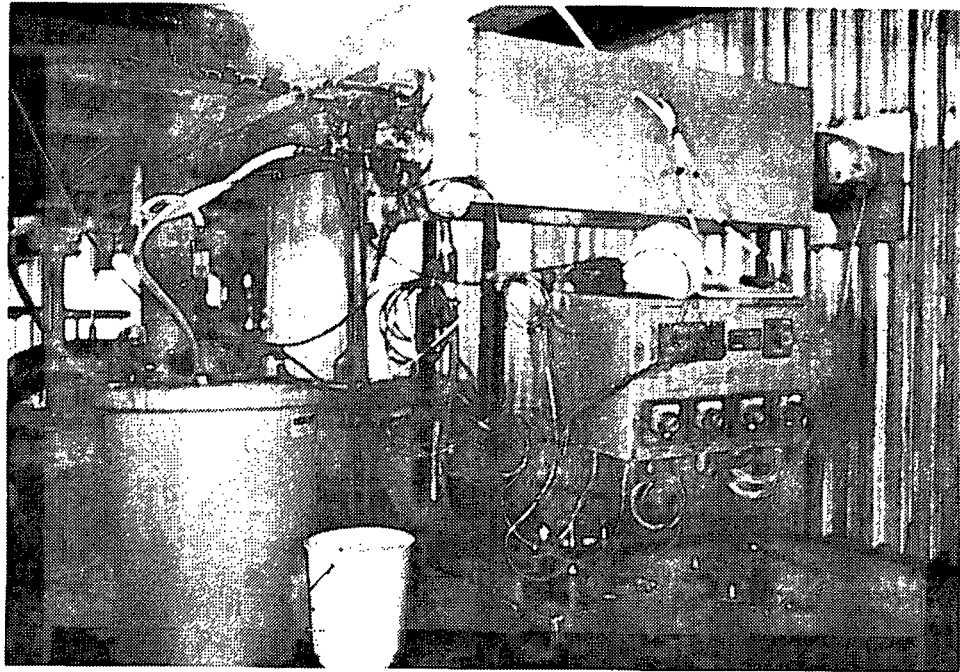
As was mentioned under Task 3, the test chamber was removed from the Westvaco mill. Two modified chambers were installed at the Great Southern Paper Company mill; one in the flue gas stream directly downstream of the economizer section (Fig. 51), and the other in the flue gas stream downstream from a cascade evaporator (Fig. 52). Flue gas is withdrawn from the main recovery boiler ductwork system, through the test chambers, and returned to a downstream location just before the precipitator. Corrosion coupons are mounted on controlled temperature surfaces ("cold fingers", see Fig. 25) that use air and water cooling to sustain preselected temperatures and simulate cold, corroding internal precipitator surfaces. Corrosion rates were determined by measuring the weight loss of the corrosion coupons. Each system was capable of simultaneously determining corrosion rates for 40 specimens in a range of temperatures from 100 to 350 °F.

Figure 51. A flue gas corrosion test chamber was installed near the economizer section of the No. 2 recovery boiler at Great Southern. Gases are drawn into the chamber through a heated pipe system, where corrosion specimens are mounted on controlled temperature probes.

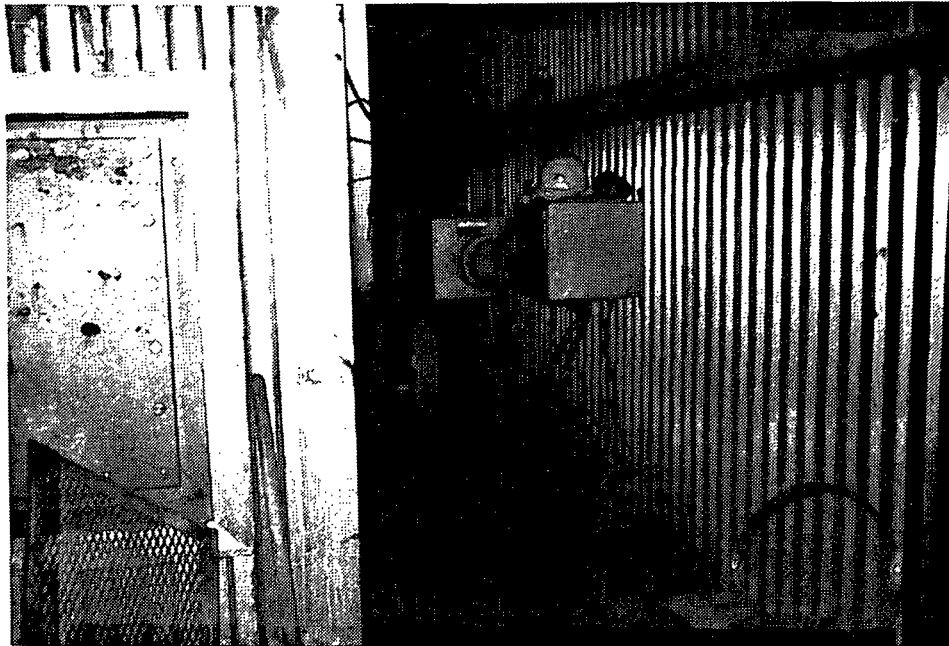
Figure 52. A second test chamber was installed in the flue gas stream downstream a direct contact evaporator.

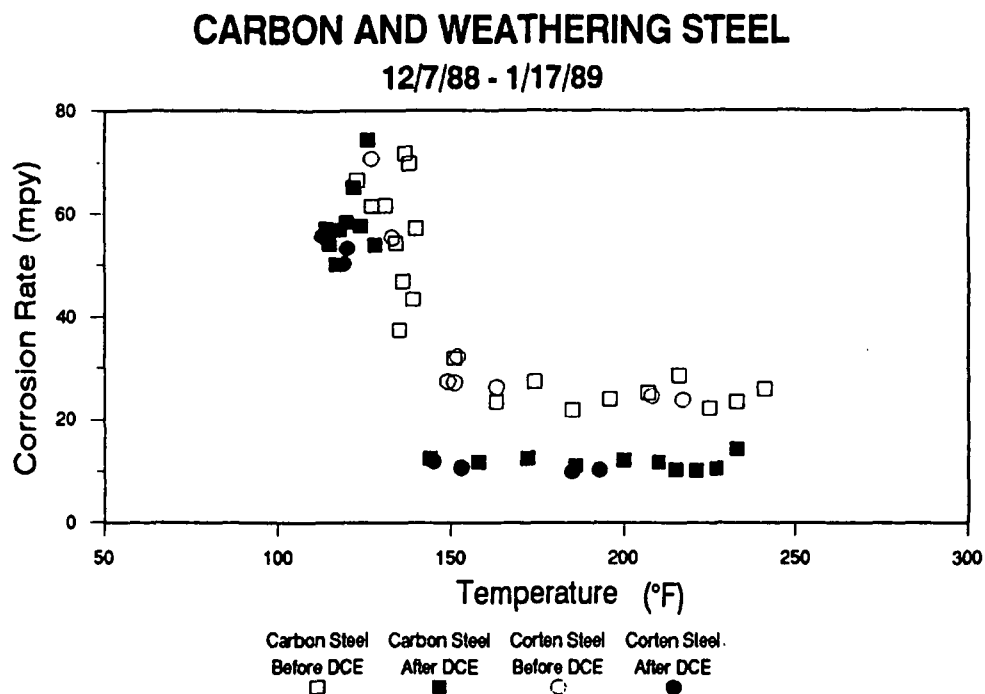
The results of each run are summarized in Figs. 53 - 56 for the carbon steel coupons, and in Tables 15 - 18 for the stainless steel coupons. The results obtained help to confirm the material ranking that was developed from previous test data. Below the water dew point, there was heavy corrosion on the carbon steel coupons and pitting was present on the 304L and 310 stainless steel coupons. Above the water dew point there was very little corrosion present on any of the coupons.

Figure 53. Corrosion data from the Cedar Springs mill without saltcake on the coupons.
